**ESTIMATED RESERVE REQUIREMENTS
FOR
PEACHTREE-MALONE
CONDOMINIUM ASSOCIATION**

Prepared by Huie Services, Inc.
November 9, 2014
© All rights reserved

NOTES TO PEACHTREE-MALONE RESERVE FOR YEAR ENDING 12/31/13

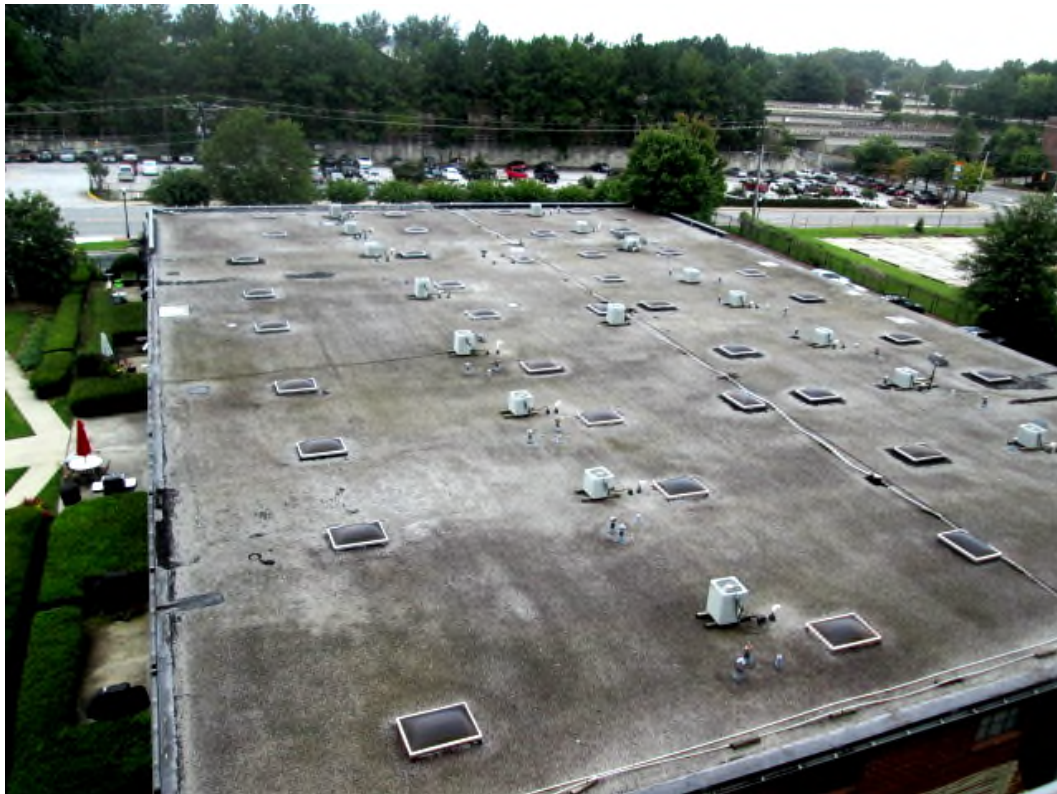
Flat Roof Replacement - 20 year normal life. The flat roofs at Peachtree-Malone are of two types. The one-story buildings have BUR (i.e. built-up roofing) roofs. This type of roof consists of layers of felt (i.e. tar paper) fully embedded in hot liquid asphalt. The surface is covered with gravel to protect the roof from physical damage and ultraviolet radiation. It appears that the roofs for these two buildings were not replaced during conversion. There were numerous areas where repairs could be seen. In the photo below of the 200 Building numerous repairs can be seen around skylights and other roof penetrations.

There also were areas where the gravel had been scraped off so that the underlying roof membrane could be checked for leaks. While the life of the roof is hard to judge because it is covered with gravel, the general appearance would indicate that the 100 and 200 building roofs are approaching the ends of their lives. This assessment is somewhat contradicted by the lack of reports of roof leakage over the last four years. The costs for repairs at these two roofs is very similar, approximately \$2000 a year. Considering the cost of replacement for these roofs, \$2000 a year to extend the life of the roof is a reasonable expense.

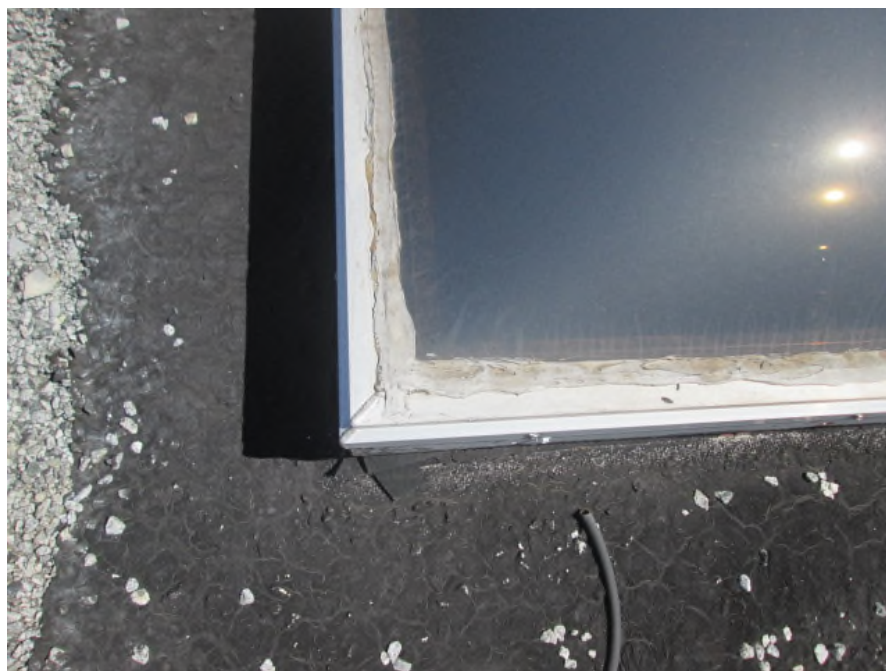
When the roofing is done at all of the buildings, the skylights will need to be removed so that the roofing can be properly installed at the curb on which the skylights sits. Then the skylight will need to be reinstalled. Consideration should be given to the replacement of the skylights at that time rather than reinstalling the old skylights. Numerous skylights can be seen that have already required remedial work (see next photo) and removal, storage and reinstallation will tend to aggravate problems with these moderately priced skylights. The skylights are the responsibility of the owners where they are over a unit so that cost may need to be billed to the owner.

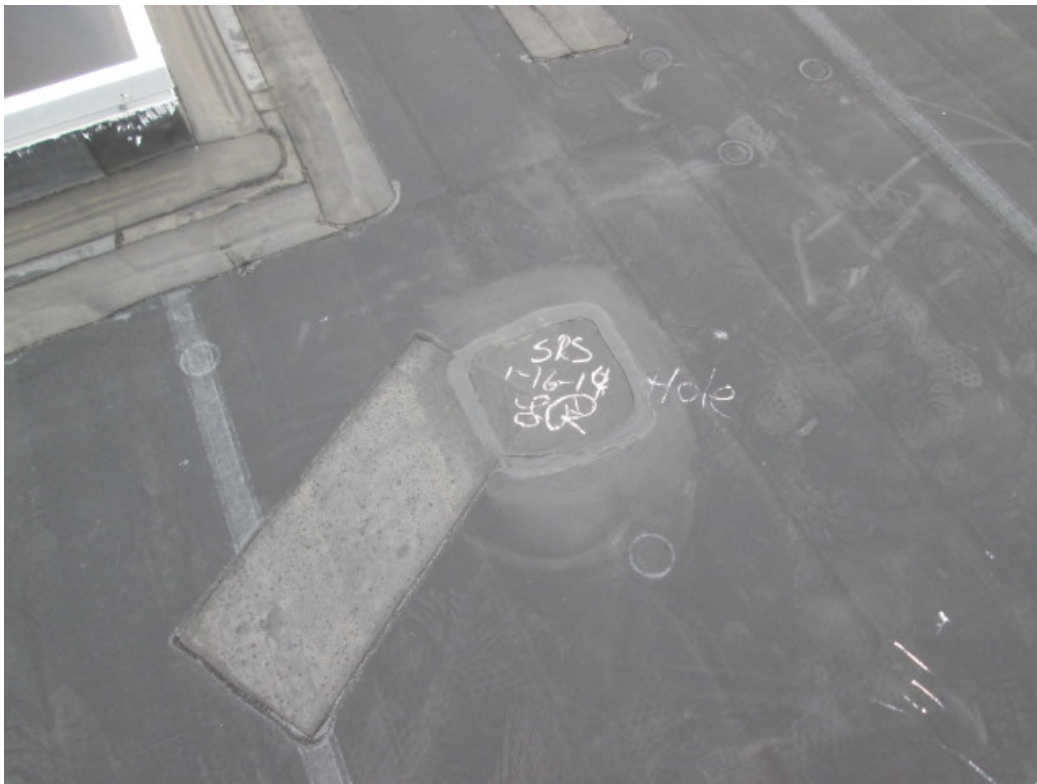
In reviewing the maintenance work on the 300 building roof, a large number of the repairs made to the EPDM roofing have been around the curb-mounted skylights. Some repairs have been made where the bottom edge of the skylight meets the roof. The repairs have been made where the membrane extends up onto the curb and then down onto the roofing field. The remaining repairs have primarily involved repairs to holes in the roofing field although there have been some issues with seams. Repairs on roofs in general and EPDM roofs in particular should only be done by qualified (and preferably manufacturer approved) roofers because use of an incorrect product can do more harm than good. Many products that work well on a BUR system cause deterioration on an EPDM roof. In the next photo a repair was made by installing a patch using additional EPDM.

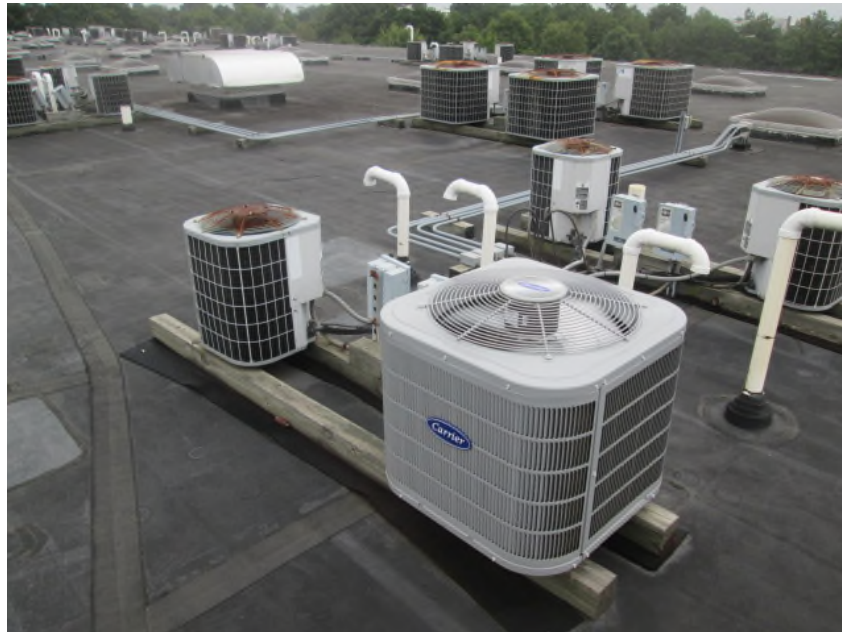
One additional issue that affects all three of the roofs is the necessity of “working around” the HVAC units that are on the roof (see the next photo). Removing the units and either moving them to the ground or shifting them to another part of the roof requires certain procedures to be followed in order to avoid the escape of the refrigerant. Therefore, a licensed HVAC contractor will need to perform the work. If the units are left in place and the contractor tries to lift to them and roof under them, it is possible that damage will occur to the units and that the work

underneath the units will be something less than the Association might desire.

When roof replacement is necessary, it is recommended that you determine ahead of time the precise roofing system that you want to use and the logistical issues involved in the installation of that roofing system before soliciting several bids from quality oriented, long established roofing companies that have a reputation for quality installation work. The price of a new flat roof (4 to 5 times as expensive as shingle roofing) will depend on the type of roofing system used and the life of the system used. You should always consider using the best system because the difference in the price between a 15-year roof and a 30-year roof could be as little as 25%.

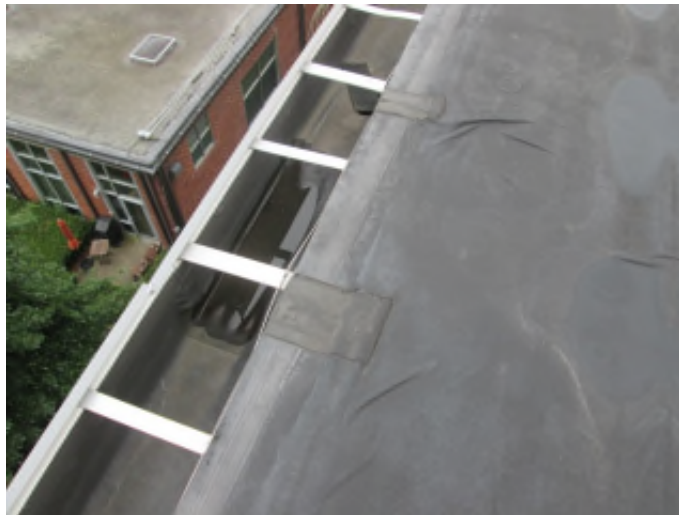
Guttering & Downspout - 35-year normal life. The existing guttering at the 100 and 200 Buildings is 6-inch coated steel box guttering with 3X4-inch downspouts. The 100 building also has some downspouts that have conductor heads (i.e. small boxes designed to catch a concentrated flow of water) on the back side of the building. The guttering at the 300 building is 7-inch coated steel box gutter with 4X5 inch downspouts and the inside of the guttering has also been wrapped with the EPDM roofing membrane (see next photo). The eventual failure of guttering and downspouts is primarily due to physical damage.

In general, it is best to replace the guttering at the flat roof areas when the roofing is replaced so that the two systems mesh together. Replacing guttering alone often causes problems with the roofing where they intersect. The existing guttering at the 100 and 200 buildings is less integrated into the roofing so it will (with care during the roofing process) not need replacement until the end of the life of the next roof.

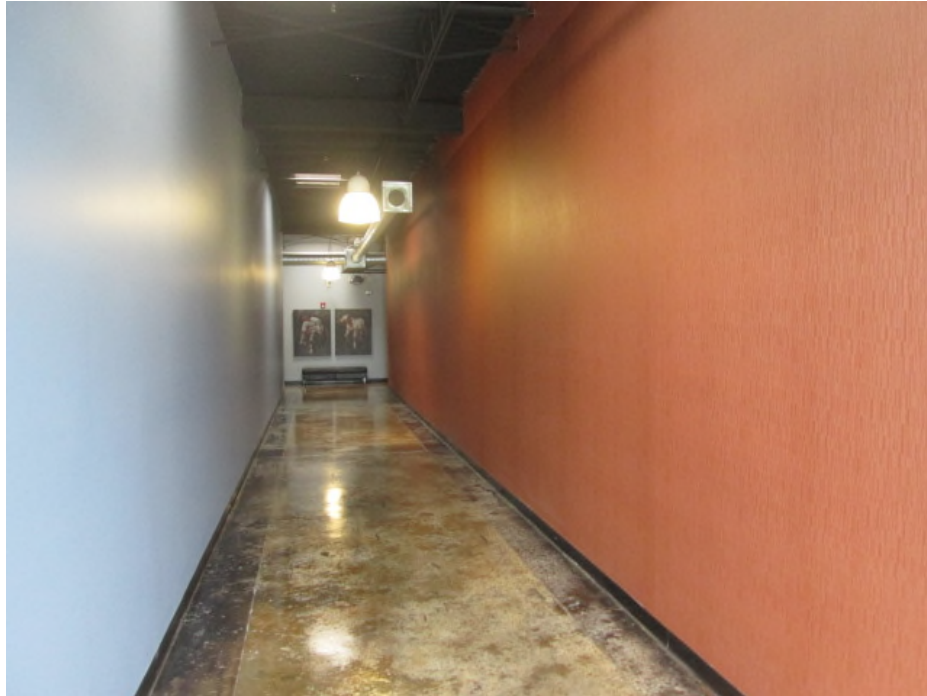
The interior hallway floors are concrete that has been stained and sealed. The surface has performed well and should continue to do so for an extended period of time. In the 300 building a few issues were noted outside the elevators, but otherwise the floors were in good condition. An allowance is included for the concrete floors but it is doubtful that much will need to be done for the short to mid-term.

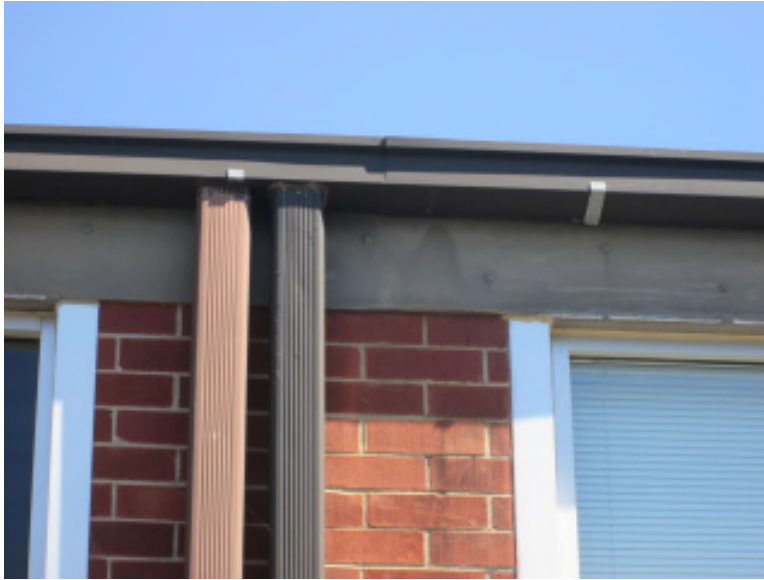
Exterior Rehab - 7-year normal life. This includes washing, repair, preparation and painting of the three buildings using the same or a similar color scheme with one coat of gloss silicone-alkyd paint. There is little to paint on the exterior at Peachtree-Malone. Most of the exterior is brick and the doors and windows are mill-finished aluminum. The steel railings and beams at the 300 building are the bulk of the painting but there are a few exterior areas at the 100 and 200 buildings that will be painted. Most of the metal fencing, gutters and downspouts have a factory applied finish but they will fade and you will eventually want to include them in the exterior painting. It was noted that there are multiple prefinished colors on the gutters and downspouts at the 200 building (see next photo) that could be made uniform during a painting process.

It appears that the present condition of the paint is fair and bids are being solicited to repaint the exterior. This would include, although not necessarily at each **Exterior Rehab** project, the areas in the garage under the 300 building. The walls and ceiling are generally satisfactory but there are some yellow areas on columns which are peeling and need to be repainted.

In earlier times an oil-based paint would be used on steel surfaces but acrylic paints are now available that are designed to be applied on steel surfaces. Using quality orientated painters is strongly recommended when painting metal surfaces. It is very easy to “hide” un-prepped metal which will become visible after a short time of the rehab work being completed.

Care should be taken to formulate a set of detailed specifications for the Exterior Rehab project to ensure that you are doing everything that needs to be done.

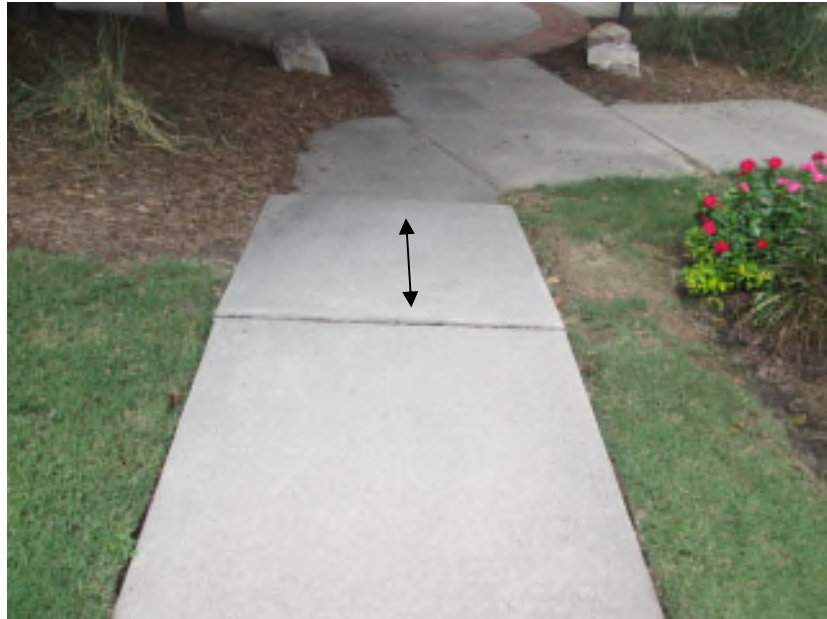
The most pressing repair needed is at the sidewalk to the 200 Building from that brick area where the section is misaligned as seen in the next photo. The irregularity is not excessive but it is by definition enough for someone to trip on.

When making repairs to masonry items it is important to use an experienced worker. An ugly masonry repair remains ugly. The “normal life” of this category has been changed to 5 years to coincide with the **Asphalt Repairs** so that curbing repairs can be made at the same time. The cost has been adjusted also.

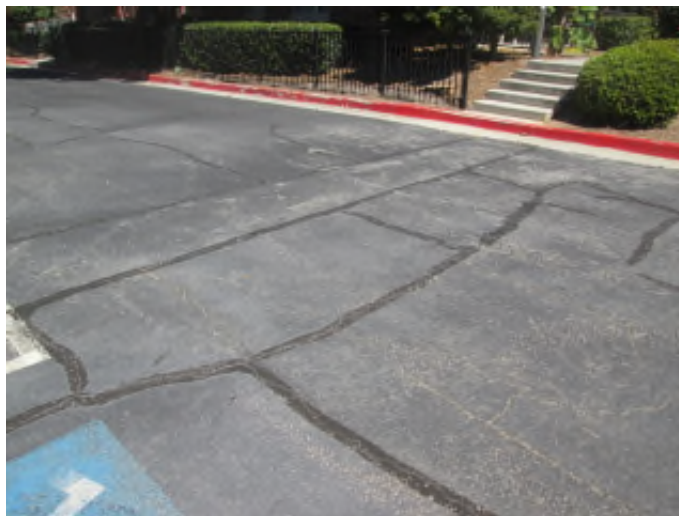
You have also applied a crack-filler to some of the cracks. While it has had some effect in sealing cracks, it is more effective if the crack is filled. The cosmetic problem with the crack-filler is that it is rubberized and the seal-coating does not adhere well to it. In the next photo you can see how the seal-coating has worn off, exposing the pattern of crack filling. Crack filling costs about \$0.75 per linear foot (LF). An average allowance for 2000 LF is included.

Lastly, as also seen in the next photo, there is 375 LF of curbing painted red to indicate a fire lane. The curb needs to be pressure washed to remove the loose paint and dirt before washing at a cost of about \$1 per LF if done at the same time as the other work.
