**ESTIMATED RESERVE REQUIREMENTS  
FOR  
PEACHTREE-MALONE  
CONDOMINIUM ASSOCIATION**

Prepared by Huie Services, Inc.  
July 25, 2010  
© All rights reserved

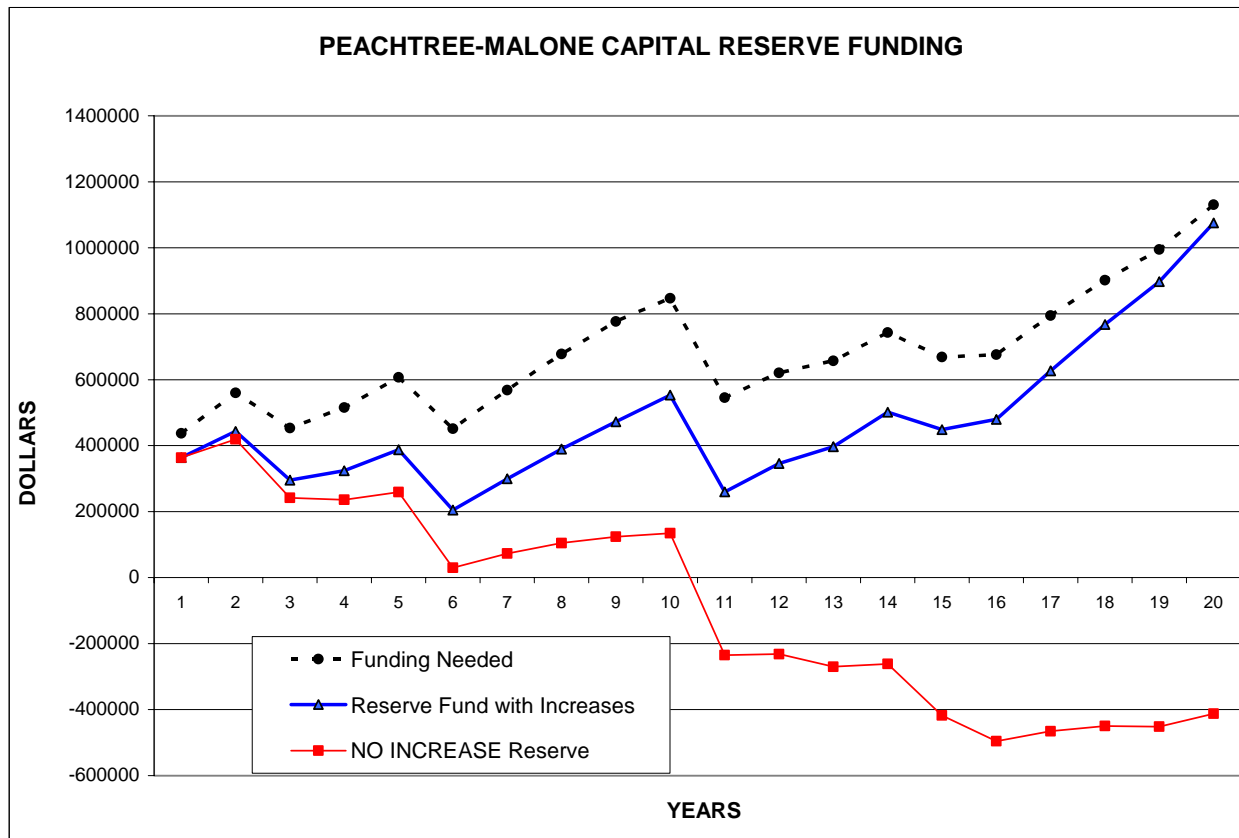
This is a long document containing a lot of information that can be summarized as follows: **you have enough money to fund the short and mid term expenses but are unprepared for the long term expenses.** The graph directly below illustrates where you are now (year 1), where you need to be (*Funding Needed*), where you will be at the present funding level (*NO INCREASE Reserve*) and where you will be with suggested increases (*Reserve Fund with Increases*).

The information used to generate this graph can be found in the last two Tables at the end of this report.

Increases in the contribution to the Reserve are needed to meet the long-term needs of Peachtree-Malone. While there are other ways to address the need, we recommend that in 2011 the present contribution to the Reserve be increased by \$15 per home per month with additional increases each year thereafter of \$3 per home per month.

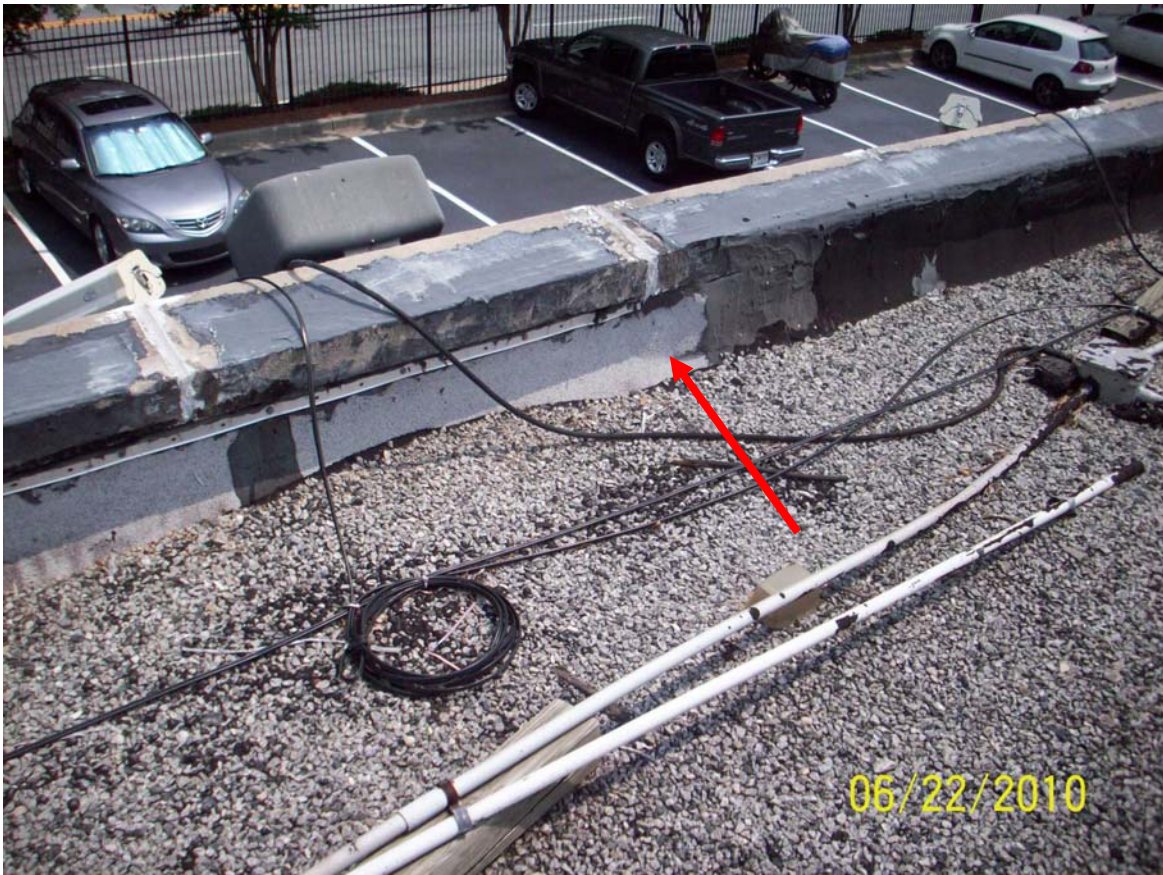
**Flat Roof Replacement** - 20 year normal life. The flat roofs at Peachtree-Malone are of two types. The one story buildings have BUR (i.e. built-up roofing) roofs. This roof consists of layers of felt (i.e. tar paper) fully embedded in hot liquid asphalt. The surface is covered with gravel to protect the roof from physical damage and ultraviolet radiation. It appears that the roofs for these two buildings were not replaced during conversion. There were numerous areas where repairs could be seen. In the photo below taken on the 200 Building, the white colored membrane on the short parapet wall is a repair. Numerous repairs were seen around skylights and other roof penetrations. There also were areas where the gravel had been scraped off so that the underlying roof membrane could be checked for leaks. While the life of the roof is hard to judge because it is covered with gravel, the indications are that it is approaching the end of its life. The roof on the 100 building has somewhat fewer repairs and may have more remaining life.

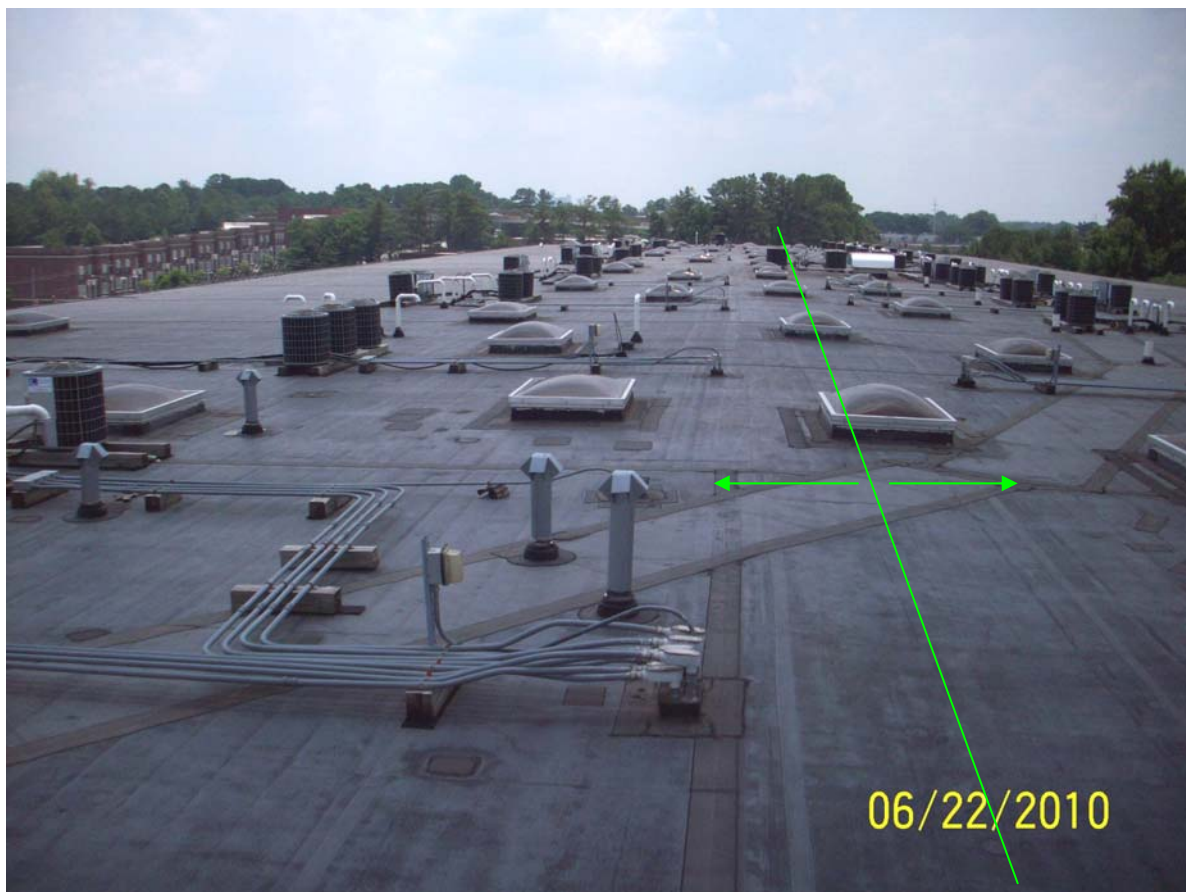
The four-story building is entirely different. It has an EPDM (i.e. rubber) that may have been

installed during conversion. EPDM roofing is an entirely different roofing system. It is single-ply membrane. The EPDM membrane is can be attached to the roof in different ways. At Peachtree-Malone, it is glued down. The surface is not covered because the rubber is not adversely affected by ultraviolet sunlight. EPDM roofs can have lives of 15, 20 or 30 years depending on the thickness of the membrane and the installation technique. Another nice feature of the 300 Building roof is that it has a ridge (indicated by the green arrow in the photo below) that runs down the center of the roof along the long dimension and the roof slopes slightly to both the front and the back (indicated by the green arrows) so that water does not pond on the roof. EPDM, unlike the BUR roofs, is not degraded by ponding water but it is best to have adequate drainage on a flat roof .

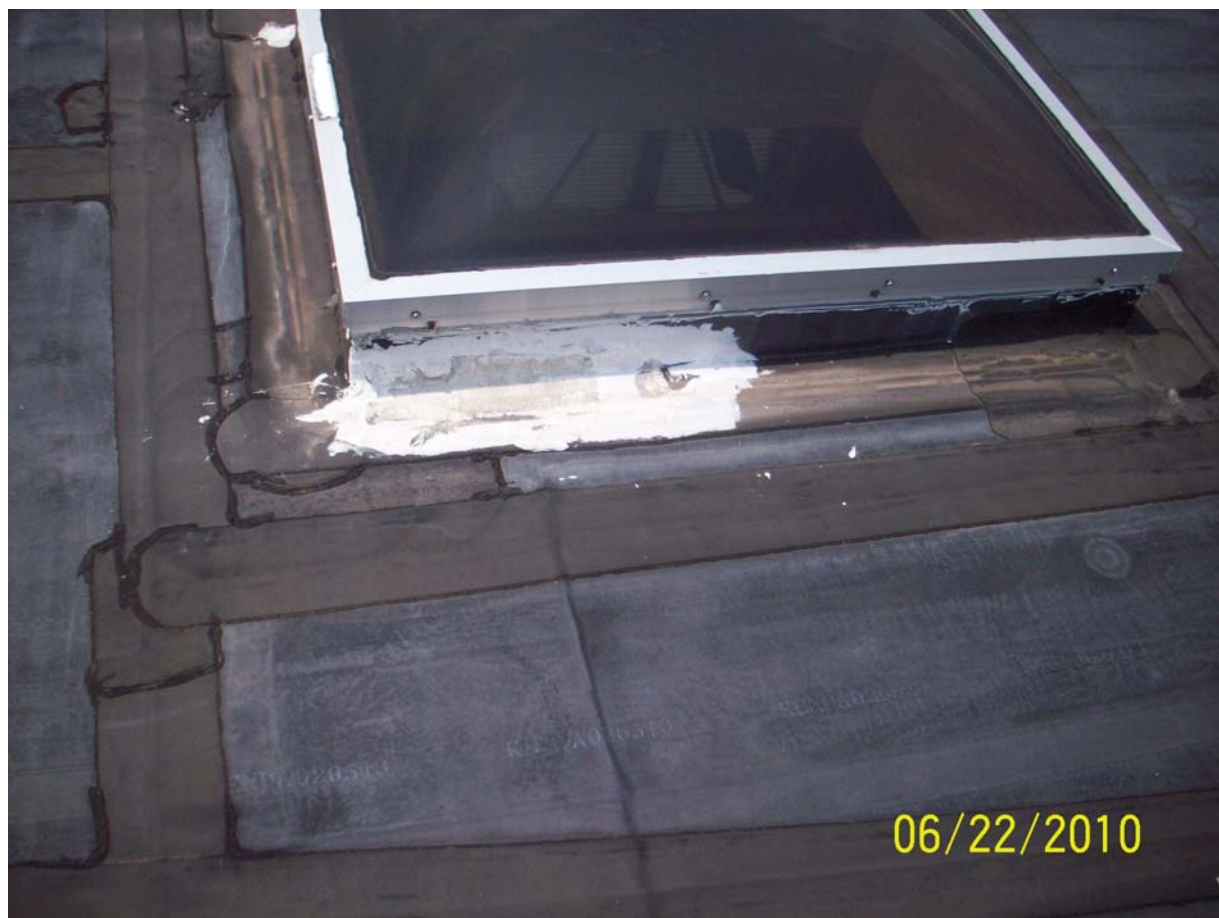
There have been some repairs made to the EPDM roofing. Most of the repairs were around the curb-mounted skylights where the membrane does not appear to extend up high enough behind the lip of the skylight (see the next photo).

Repairs on roofs in general and EPDM roofs in particular should only be done by qualified (and preferably manufacturer approved) roofers because use of an incorrect product can do more harm than good. Many products that work well on a BUR system cause deterioration on an EPDM roof.

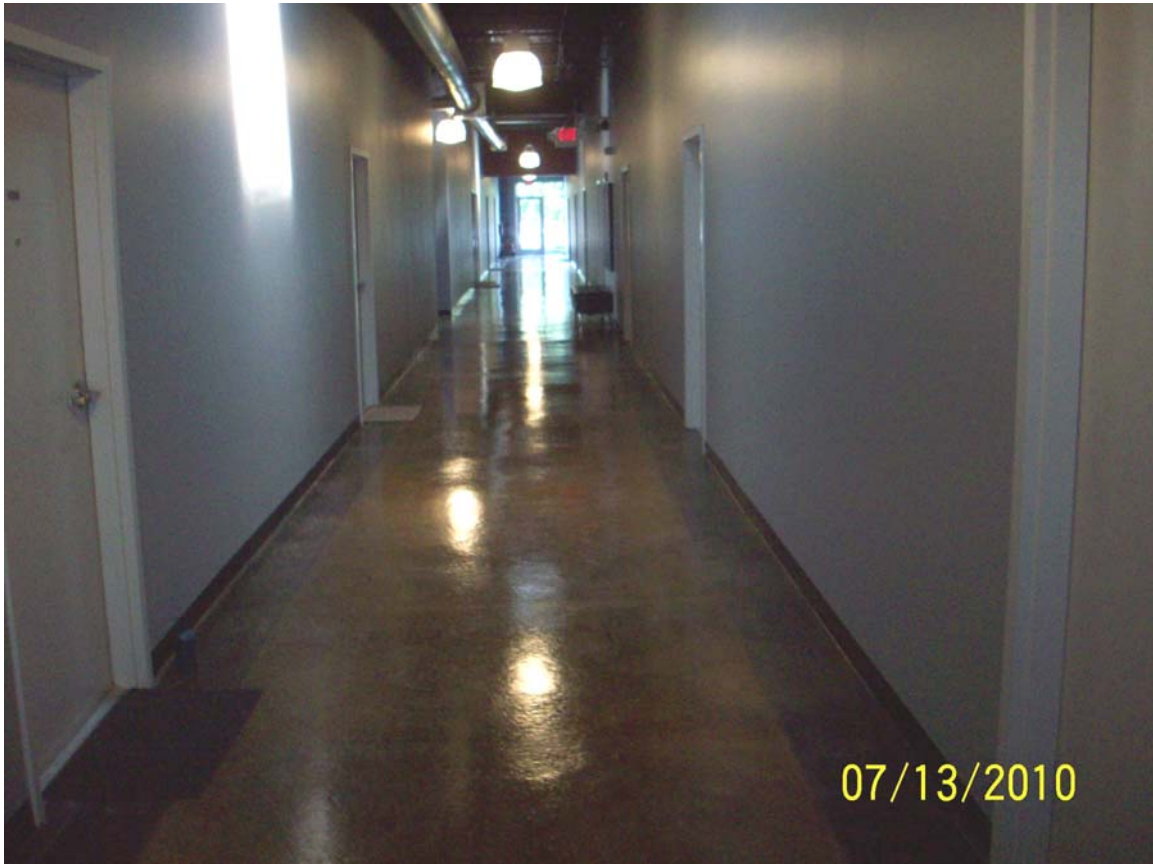
**Interior Rehab** - 10-year normal life. This category covers the painting of the 1790 LF of hallways and stairwells including unit doors and trim. There is also an allowance for areas of wallpaper. A 10-year life for the paint will require a program of cleaning and/or touching up the unavoidable marks. It is assumed that the ceiling will not be painted as it will not be subject to any significant physical abuse.

The interior hallway floors are concrete that has been stained and sealed. The surface has performed well and should continue to do so for an extended period of time. An allowance is included for the concrete floors but it is doubtful that much will need to be done for the short to mid term.

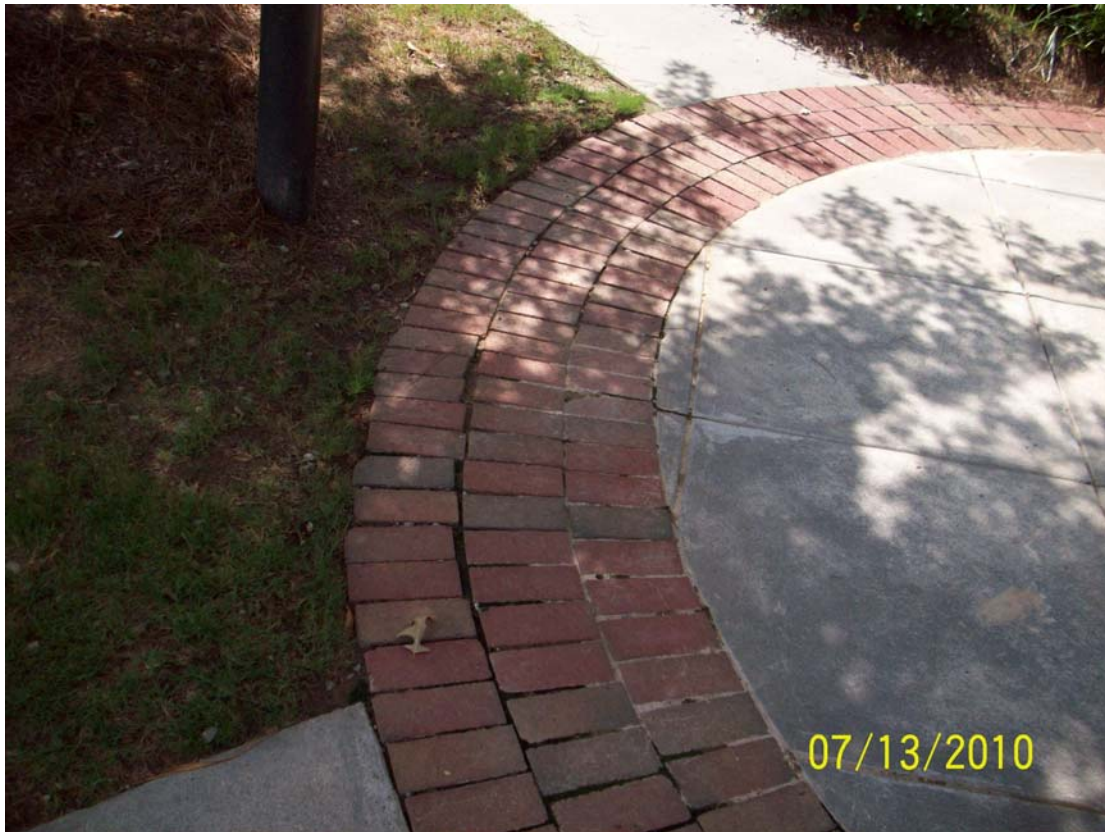
One area was noted in the courtyard where the sidewalks from the three buildings converge. There is a circular concrete section with a brick-paver border. There are some bricks that need to be re-set.

When making repairs to masonry items it is important to use an experienced worker. An ugly masonry repair remains ugly.
